INVENTORY AND ANALYSIS

Site Overview

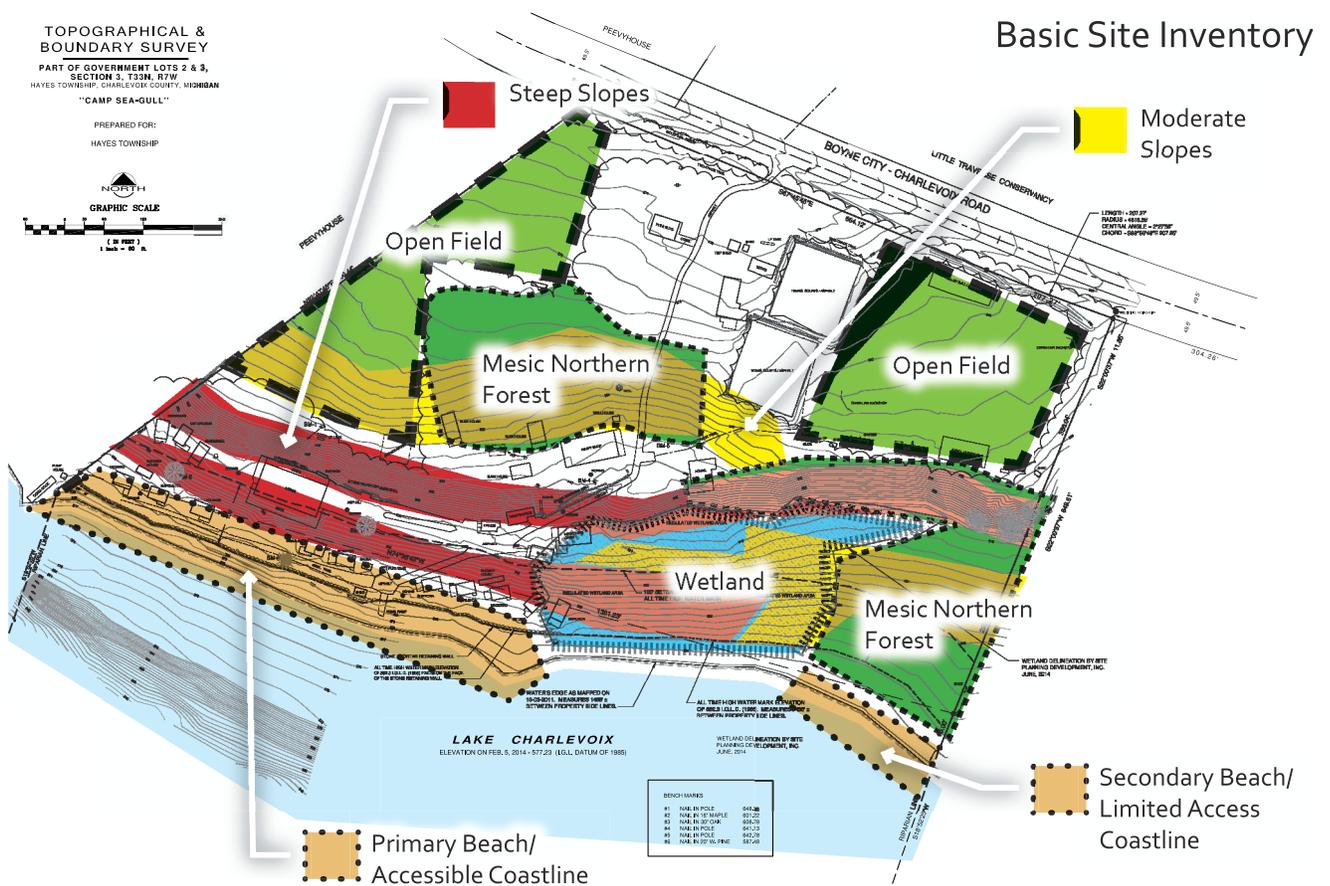
Figure 1.0 Site Inventory Diagram

Within the 20 acres of Camp Sea-Gull, areas of upland forest with steep wooded slopes lead to expansive wetlands and 1,400 ft of shoreline on Lake Charlevoix. The steep grades, quality wildlife habitats, and remnants of camp facilities were a key focus area for the site inventory and analysis.

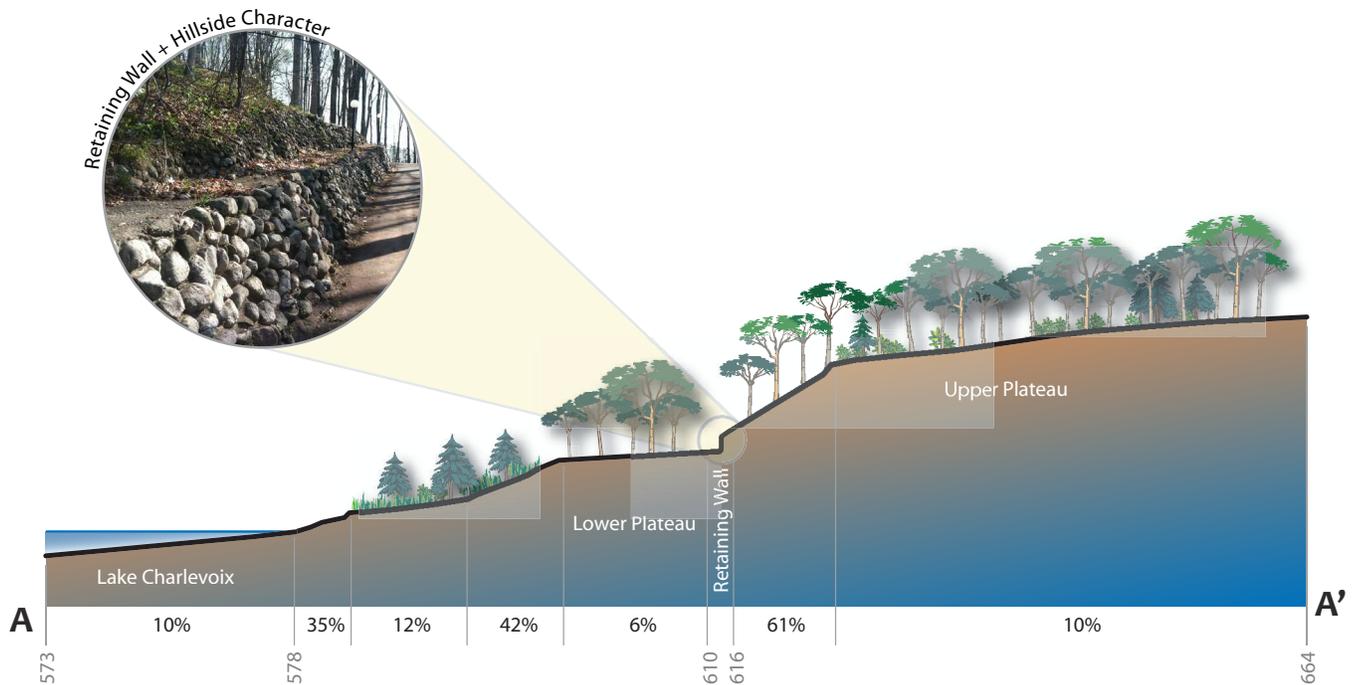
Figure 1.3 Slope Section View

A steep hillside separates the flat upper plateau of the site from the sloping lower plateau. The flat topography of the upper plateau make it well suited for parking and recreation amenities. As the grade steepens, spectacular views to the beach are framed by the wooded character of the hillside. Existing cabins and an amphitheater are built along the sloped edge. The slope is stabilized along the existing road by a rock retaining wall.

Figure 1.3 is a section view showing the elevation change of the area indicated on figure 1.1.

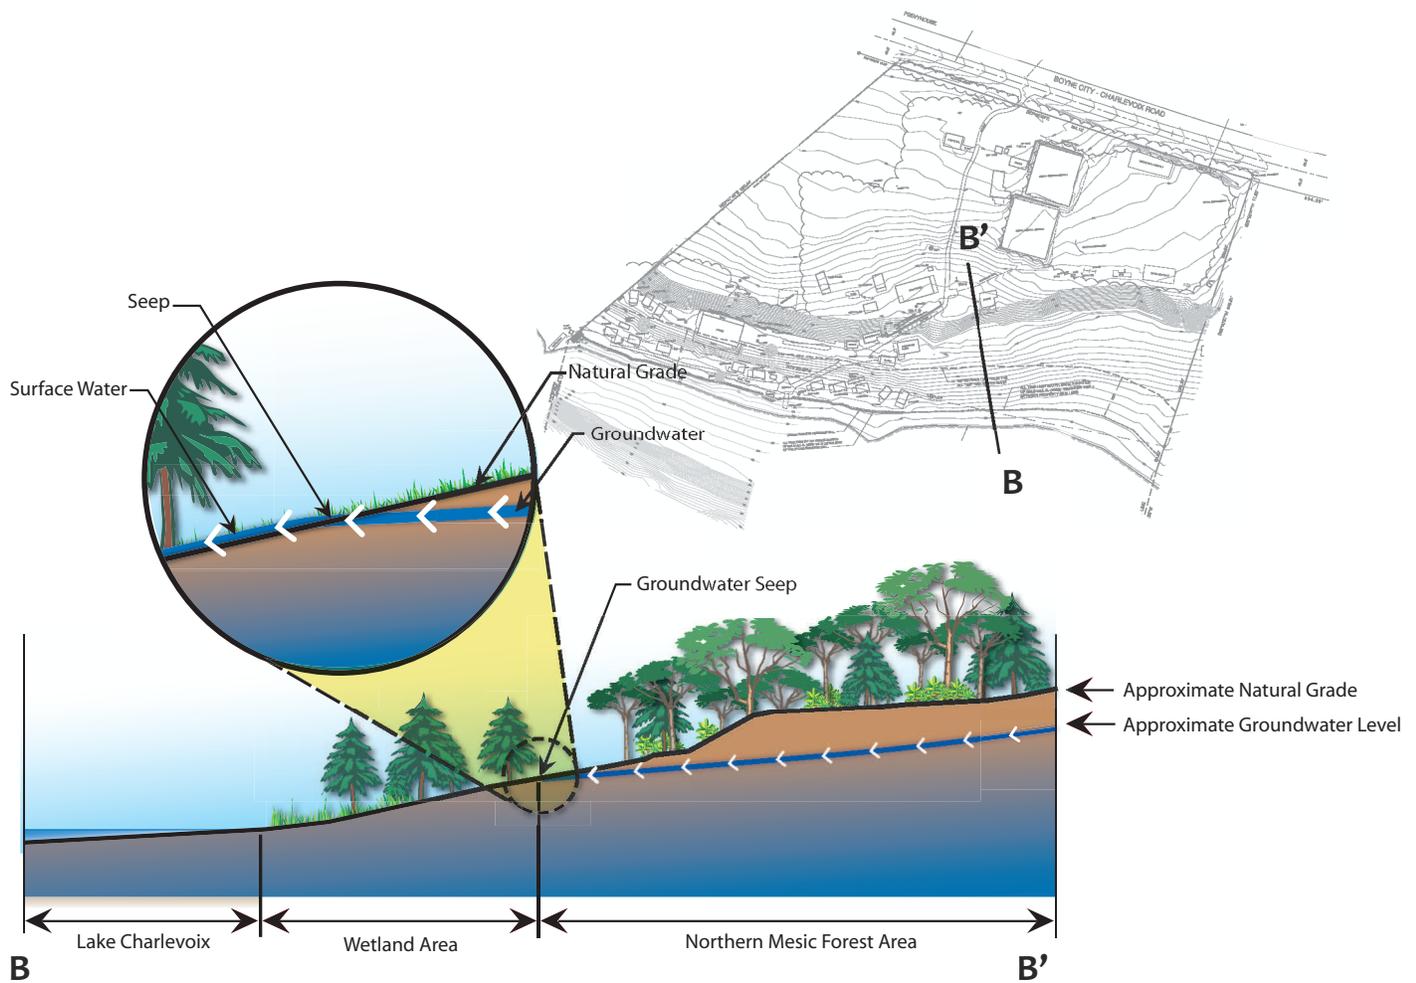
Figure 1.4 Groundwater Seeps

Field observation indicated that the elevation of the ground water table intersects the hillside, creating hillside seeps. A model was created to analyze the topography and elevation of the water table and verify the location of hillside seeps. These types of seeps create unique wetland habitats along the slopes from which they emerge, as is true of this site.

Since the groundwater level meets the grade halfway down the hill, septic fields are not a viable solution for new construction below the upper plateau.

Figure 1.4 illustrates where the seeps occur in the hillside.

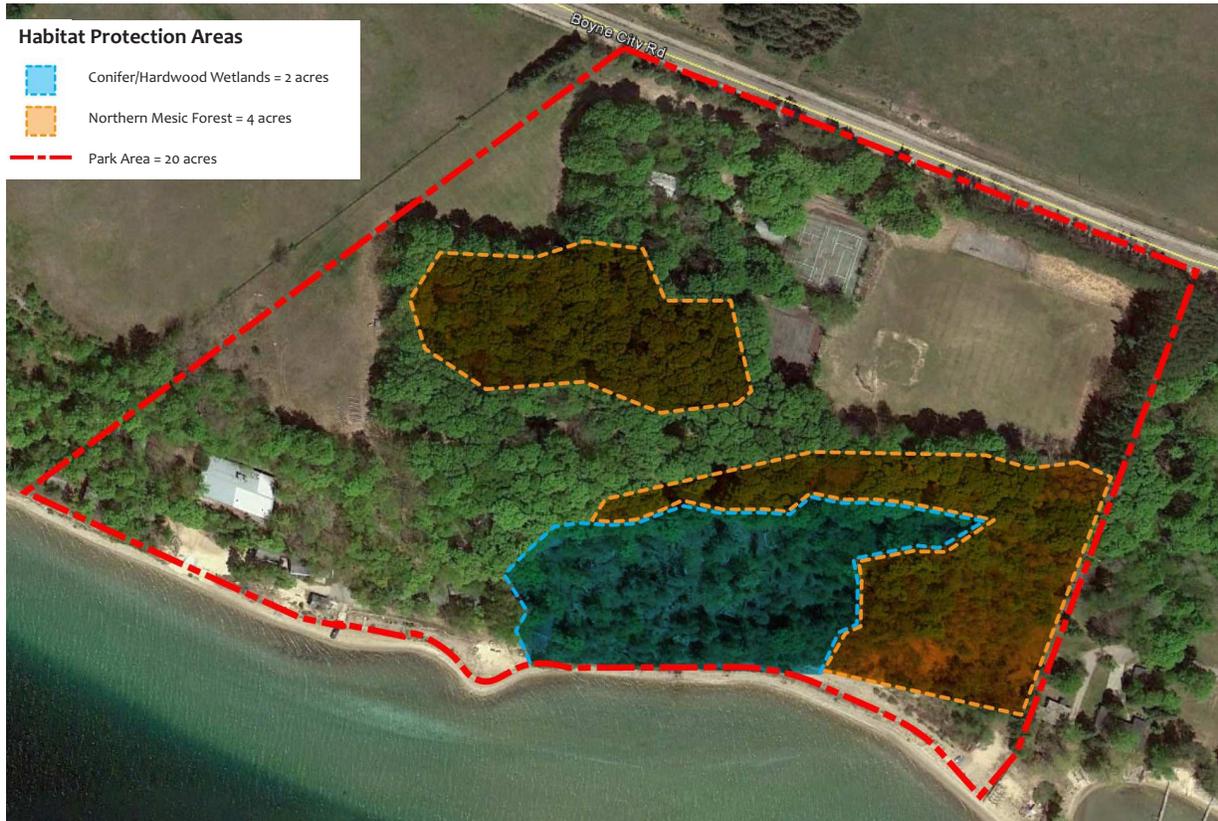
Figure 1.5 Ecological Zones

Several habitats were identified in a floristic study performed by the Little Traverse Conservancy (Plant Survey For New Hayes Township Park (Camp Sea-Gull), Charlevoix County, Michigan, June 2014). Two major habitats were found to be of relatively high quality are called out in Figure 1.5. The field report recommended preserving these habitats by avoiding significant development within them.

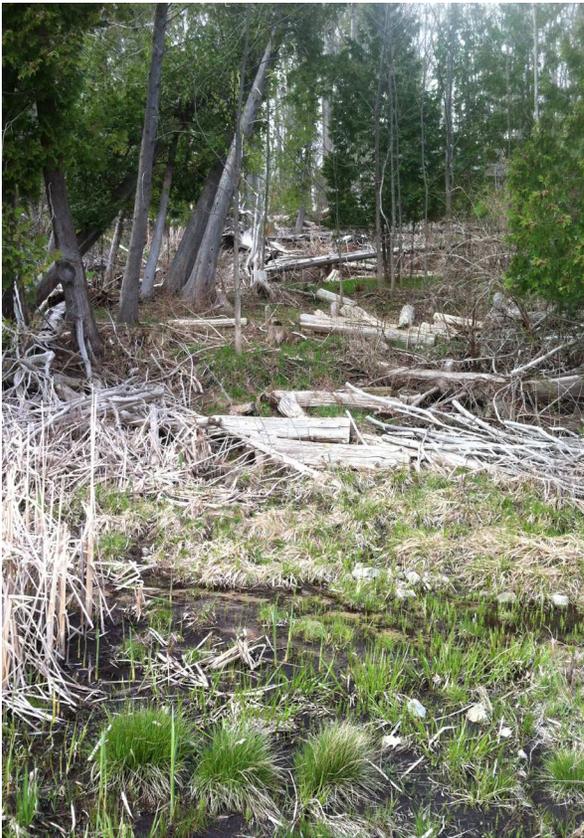
Image of conifer/hardwood wetland habitat.

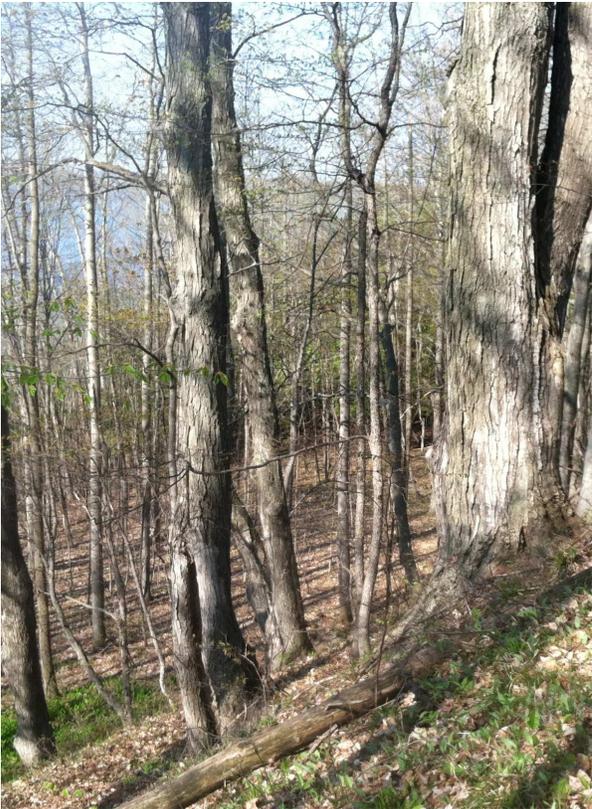
Image of northern mesic forest habitat.
