FINAL REPORT: ANALYSIS AND RECOMMENDATIONS FOR THE CAMP SEA GULL ROCK WALL

July 12, 2019

GeoEngineering North, LLC
Hancock, MI

Analysis and Recommendations for the Camp Sea Gull Rock Wall

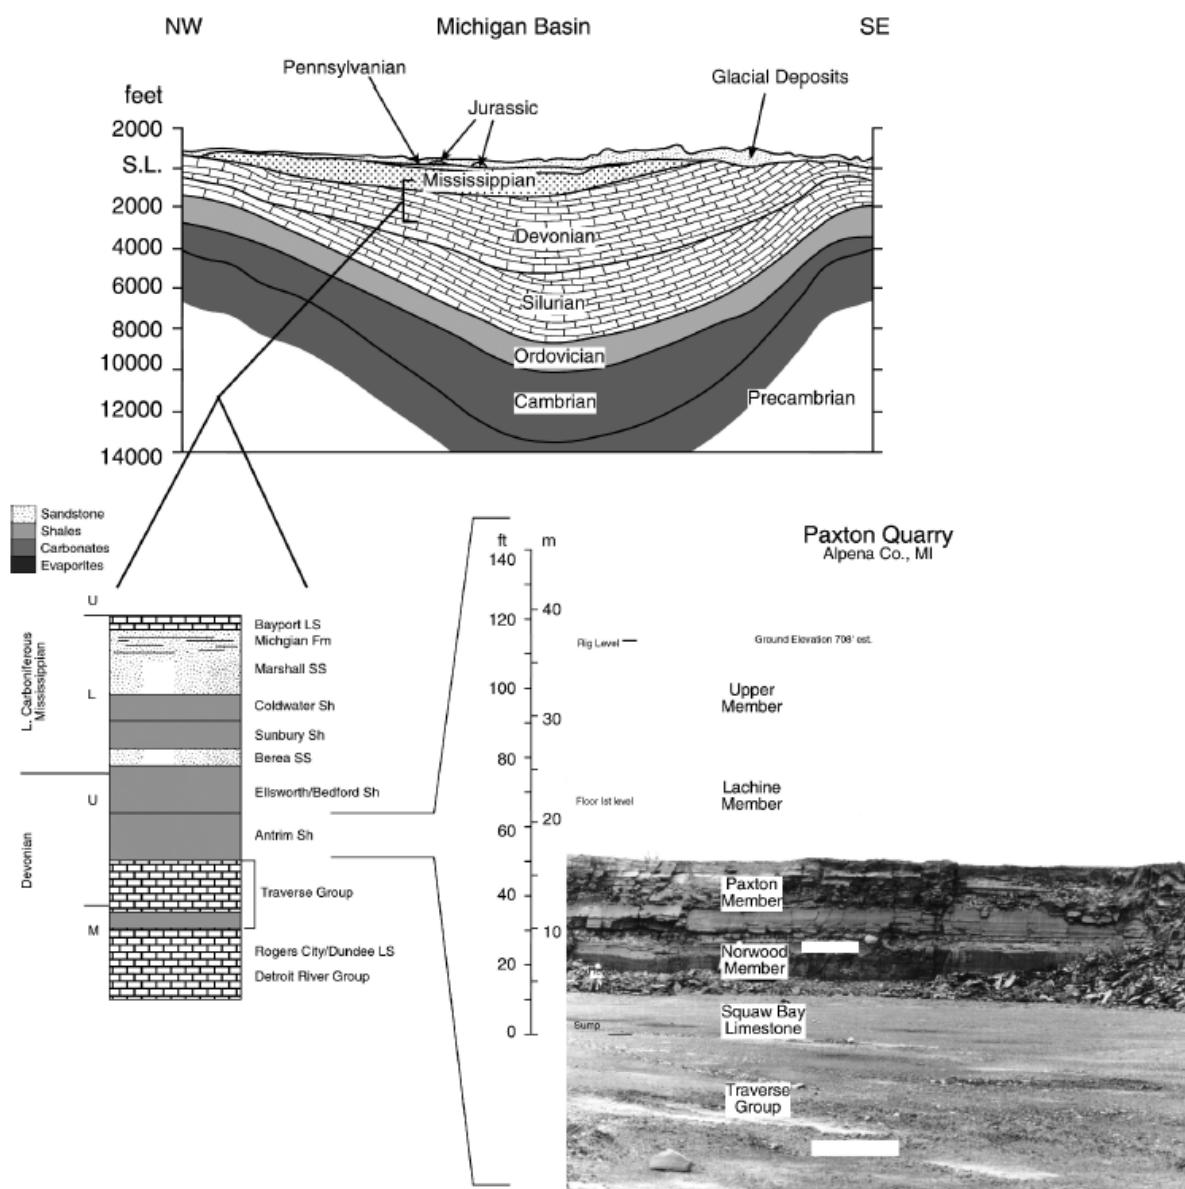
Figure 2 Cross-section of the Michigan Basin and the Upper Devonian stratigraphy in the Northern Lower Peninsula (Budai et al., 2002).

The bedrock geology of the Lake Charlevoix area is part of the Michigan Basin, a 500 hundred million old sedimentary basin composed of limestones, sandstones, evaporites, and shales. Figure 1 illustrates a cross-section of the Michigan Basin geology with the rock units in the Lake Charlevoix area being Middle and Upper Devonian in age. The two primary rock units in the Lake Charlevoix are the Traverse Group, consisting mostly of limestone and some shales and the younger Antrim Shale, noted for its oil and gas production. In 1974, the detailed geology of Charlevoix and Emmet Counties was conducted by Kesling, Seagall, and Sorensen from the University of Michigan's Museum of Paleontology. They identified the black shale at Camp Sea Gull as the Norwood Shale. A map from Kesling's report illustrating the geologic formations in western Charlevoix County is provided in Figure 3 and indicates the approximate location of the Norwood Shale. The original location called a "type location" for the Norwood Shale was located north of Norwood MI, just west of Charlevoix, which was conducted by Rominger (1876) who was the Michigan State Geologist. However, an expedition in 1926 failed to locate this outcrop along Lake Michigan. Instead, they inspected the black shale in a quarry at Kamp Kairphree¹, which was later renamed Camp Sea Gull. Rominger (1876) also notes inspecting an outcrop along Lake Pine (now Lake Charlevoix) in which Kesling believed was also at Camp Sea Gull on Lake Charlevoix. Evidence of a quarry at Camp Sea Gull, however, was not observed in my site inspections. It is possible that the area on the southeast side of the camp, where several cabins are located, might have been a small quarry at one time. Later, in 1973, Kesling et al., located a small outcrop along the Lake Michigan shoreline south of Norwood, which according to Kesling's report is the possible "Type Location." A photo of this site from the Kesling Report is shown in Figure 4. It is probable that this site is located south of Norwood along Lake Shore Drive where a small stream flows through a culvert under the road. Figure 5 is a photo of the site showing the exposed Norwood Shale. This site is on private property. Both Figure 4 and Figure 5 illustrate the Norwood Shale forms a steep bluff along Lake Michigan. Talus (broken) material from the shale can be seen in Figure 5(b).

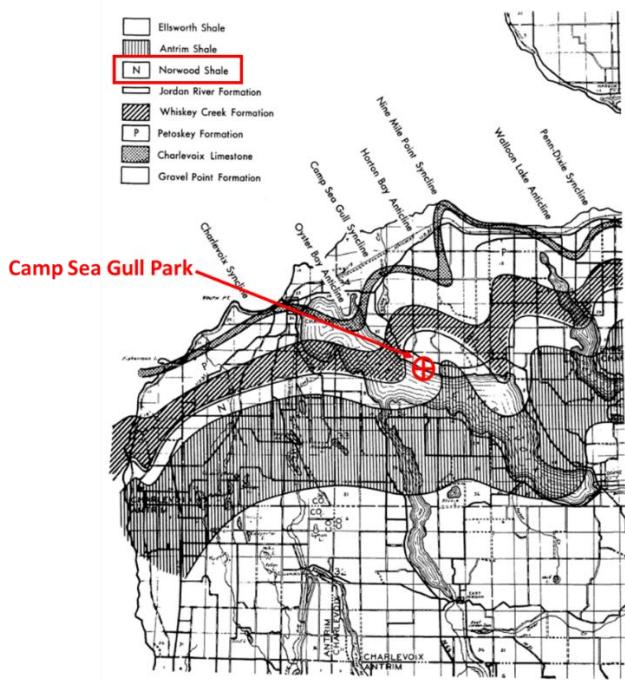
Figure 3 Stratigraphy of western Charlevoix County, Michigan from the Kesling et al., Report 1974 indicating that the shale at Camp Sea Gull is the Norwood Shale.

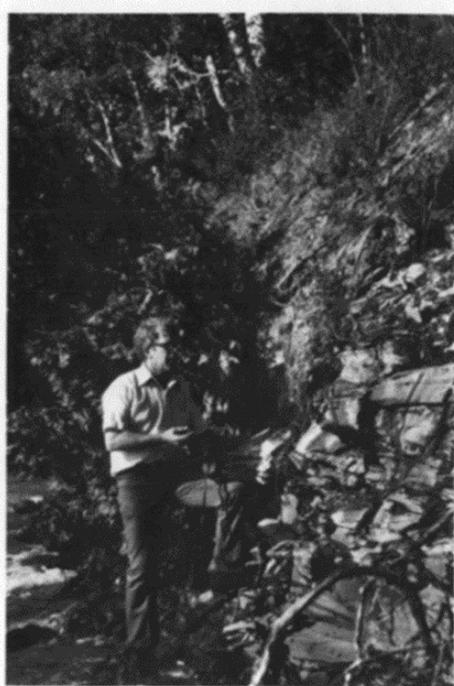
TEXT-FIG. 66 -- Antrim Shale near type locality, about 1 mile south of Norwood. Sorensen stands on one of the narrow strips of beach available at high-water level. Photo by Kesling, 29 Sep 1973.

Figure 4 The "Norwood Type" Location located south of Norwood, MI from the Kesling et al., 1974 report.

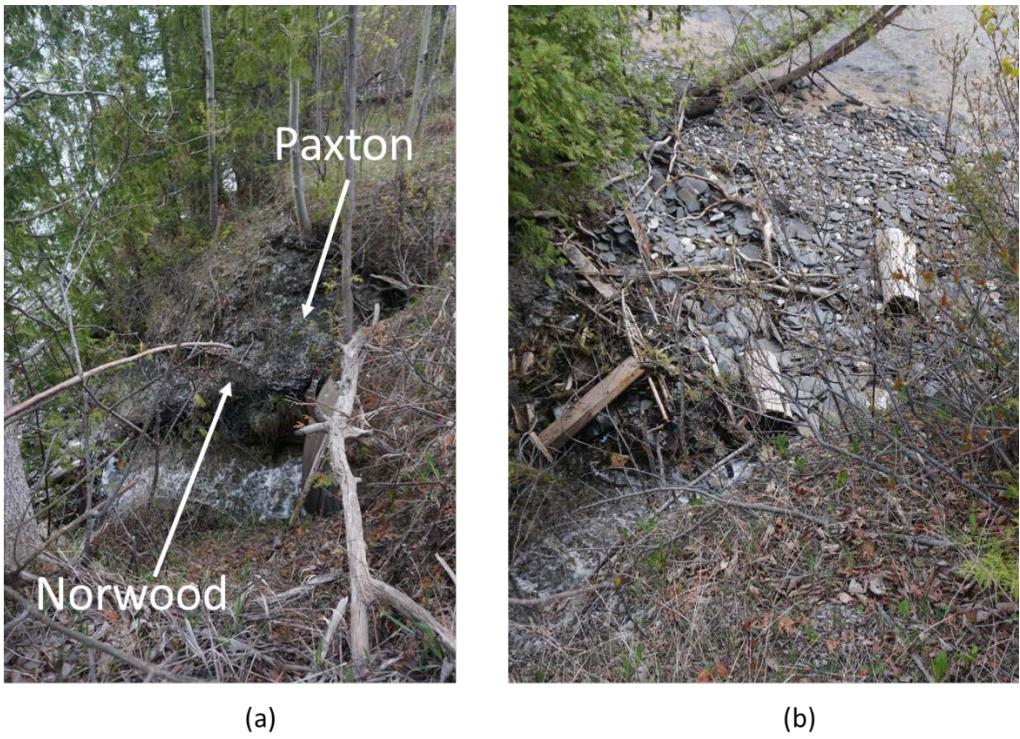
Figure 5 May 2019 photo of the Norwood Shale along Lakeshore Drive south of Norwood, MI.

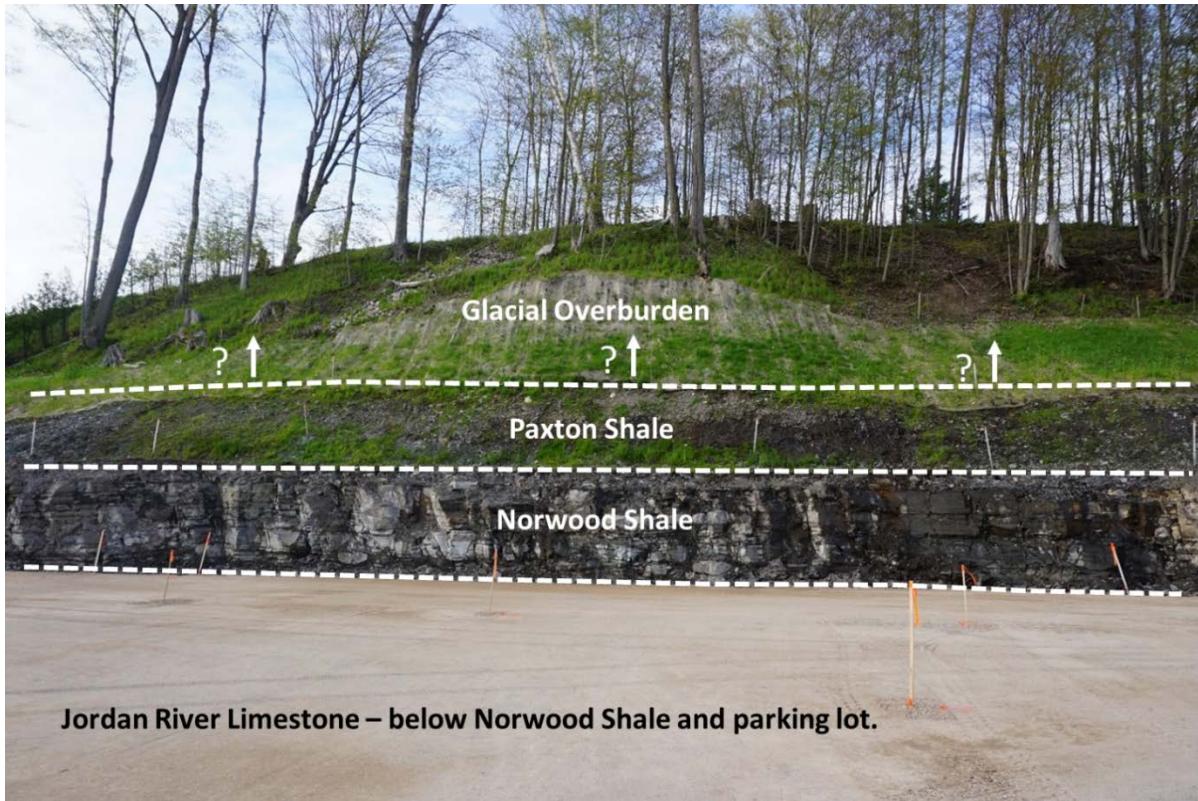
Figure 6 Glacial overburden and rock layers at Camp Sea Gull.

At Camp Sea Gull, both the Norwood and Paxton Members are present, as shown in Figure 6. The Norwood Shale is described as a black paper-shale. Geologists have interpreted this shale as being deposited in an oxygen-stratified basin with a fluctuating pycnocline, i.e., a layer in an ocean or another body of water in which water density increases rapidly with depth, producing thin laminations in the shale (Dellapenna, 1991). The thin shale laminations can be seen in Figure 7. The Norwood Shale in the Lake Charlevoix area is estimated to be between 10 and 15 feet in thickness. Structurally, the Norwood Shale is relatively flat at Camp Sea Gull but dips to the east, according to Kesling et al., (1974). Kesling et al. indicates that the shale

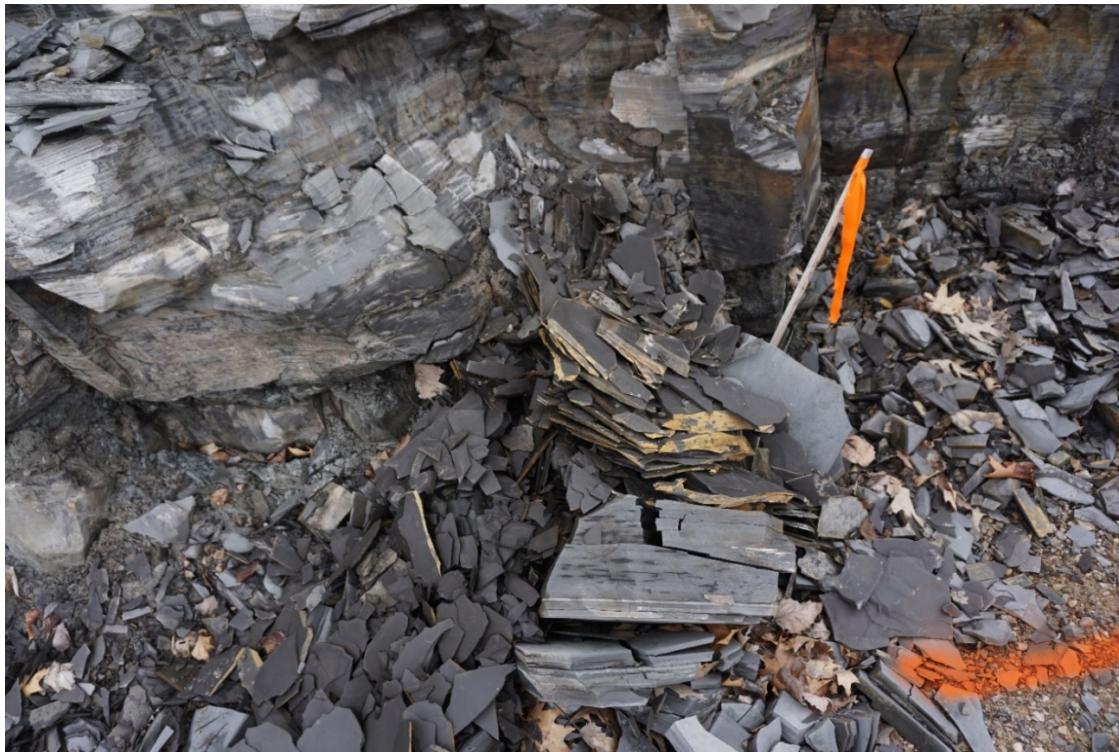
Figure 7 Norwood shale thin laminations.

Due to the construction of the shale wall, debris formed along the wall, as shown in Figure 7 due to the shale's thin laminations (bedding planes) and jointing. Figure 18 shows the shale wall after the wall had been scaled and the debris removed. Over time, a small amount of talus, will again form along the wall as the wall adapts to its new environment, the breakage will mostly cease. The rock durability tests indicate that the shale is resistant to degradation and therefore the talus slope will be stable over time.

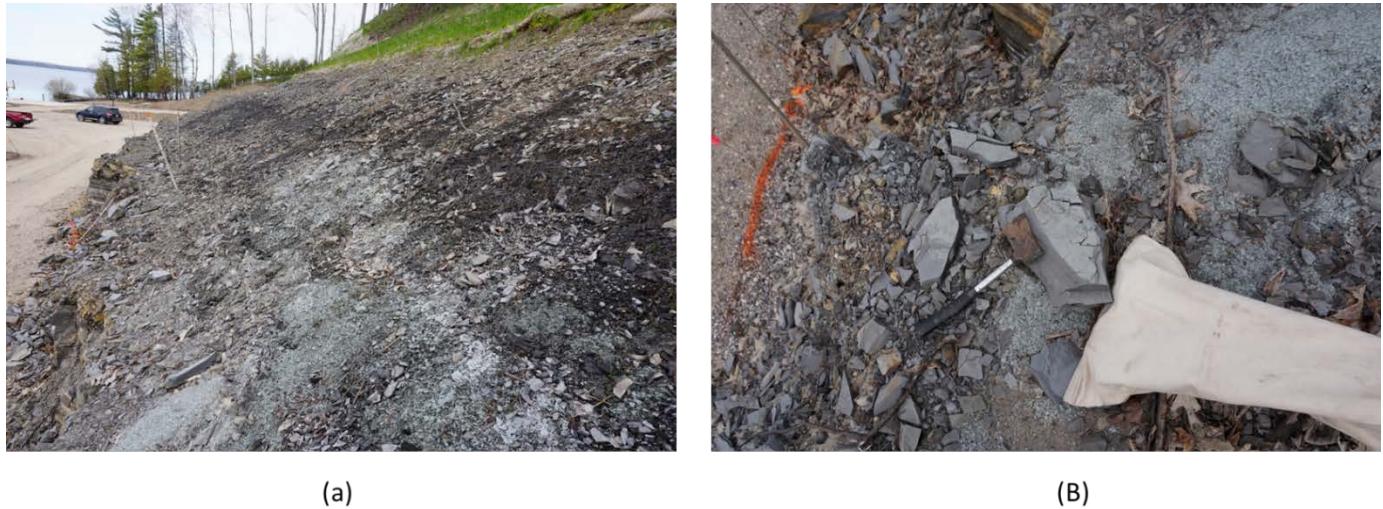
Figure 8 Paxton Member: (a) slope cut to a 1:1 slope and (b) dolomitic limestone shale.

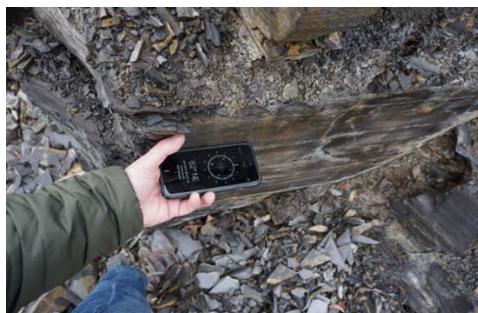
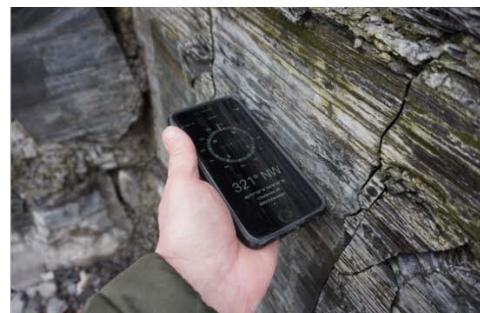
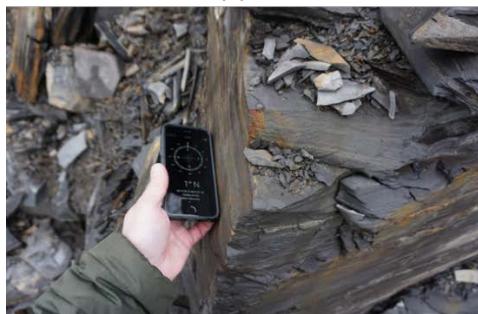
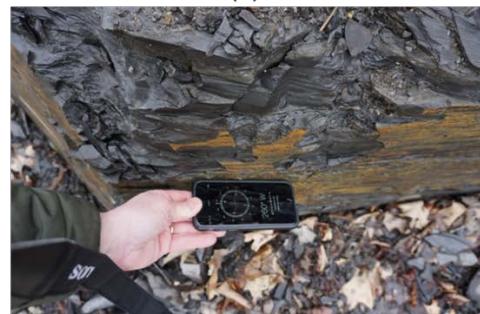
Similar joints sets were observed in the Norwood Shale at the Camp Seagull Park. Figure 9 shows the orientation measurements taken on May 2. It can be observed that the orientations of the joints are relatively close to the Antrim Shale average joint orientations reported by Ryder (1996). Further, the dips of the joints are relatively vertical. There was one joint observed, however, with an N-S orientation with a sub-vertical dip of about 60°. This joint is shown in Figure 10.

Figure 9 Joint orientations measured at Camp Sea Gull: (a) NE-SW at 062° vs 052° (formation average), (b) NW-SE 321° vs 314° , (c) N-S 002° vs 001° , and (d) E-W 260° vs 272° .

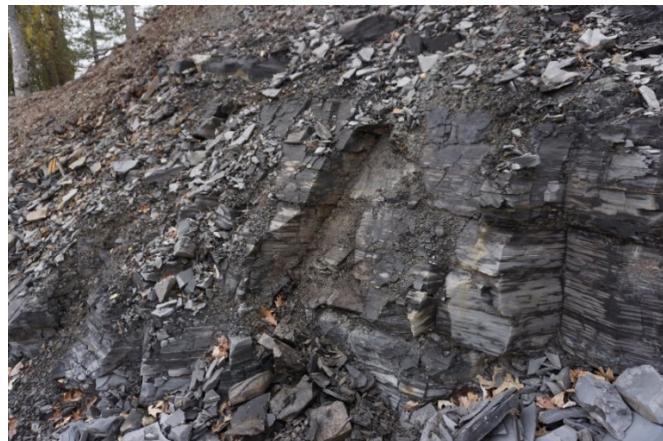
Figure 10 N-S joint with a 60° dip to the east.

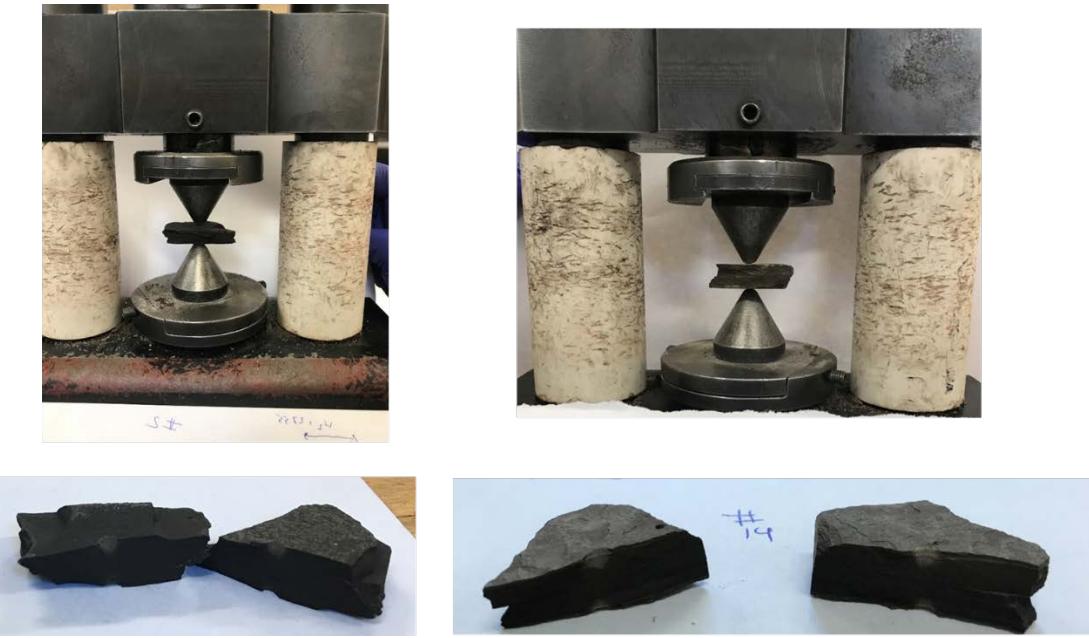
Point loads tests were conducted on the broken shale samples from the front of the shale wall. Tests were conducted parallel to the bedding, as shown in Figure 11. Due to the plate-like nature of the shale fragments, however, the diameter to width ratio just met the ASTM standard for point load testing in which most of the samples were at 0.3 or somewhat less. Attempts to fragment the samples resulted in additional delamination. Therefore, two effective diameters, D_e , were used in the analysis. One D_e based on an irregular shape and a second the distance between the load points.

Figure 11 Point load test and test samples.

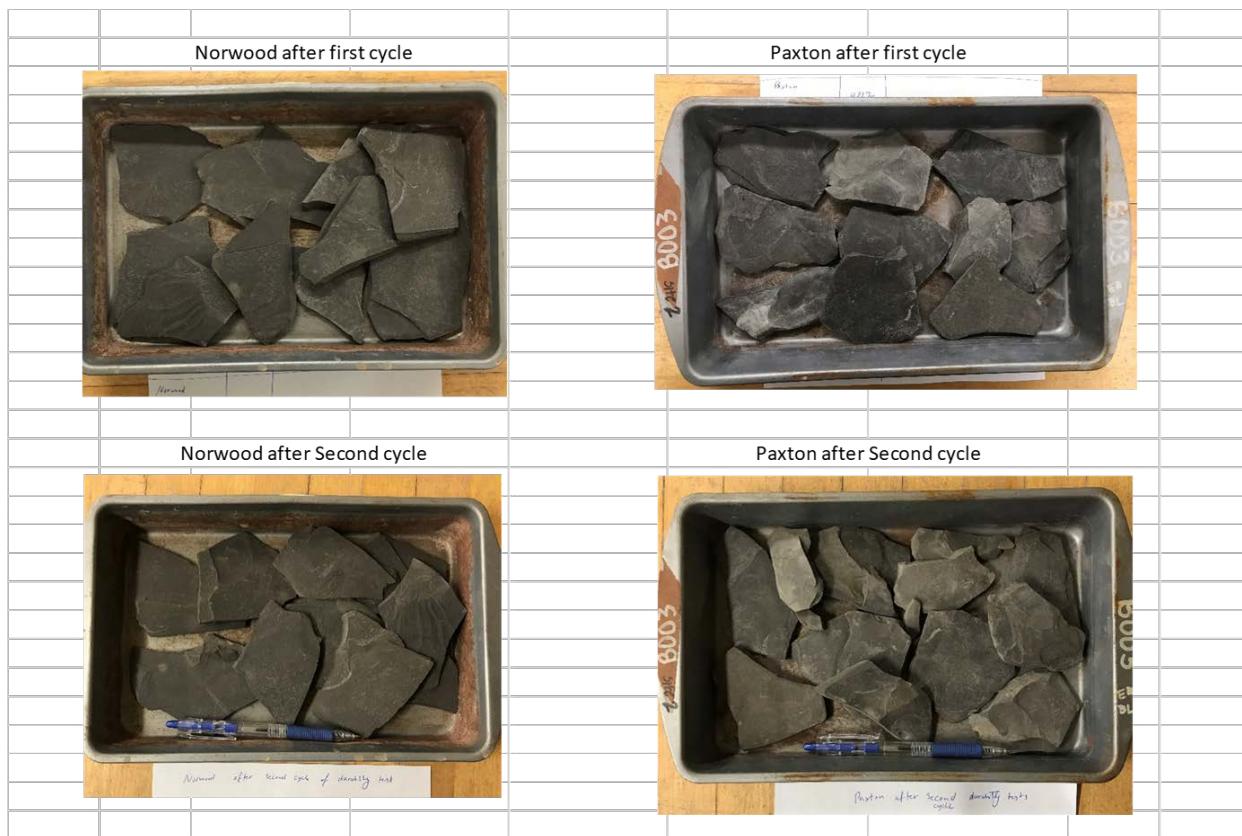
A key element for the stability of a shale wall is the shale's durability. To determine the durability of both the Norwood and Paxton rock samples, the Slake Durability and the Jar Slake Test were conducted. Figure 12 shows the test samples.

Figure 12 Slake durability tests samples.

The durability test results are shown in Table 3 and Table 4. The results indicate that both the Paxton and Norwood Shale are highly resistant to degradation with a slake durability index above 98% and no change in the Jar Slake Test.

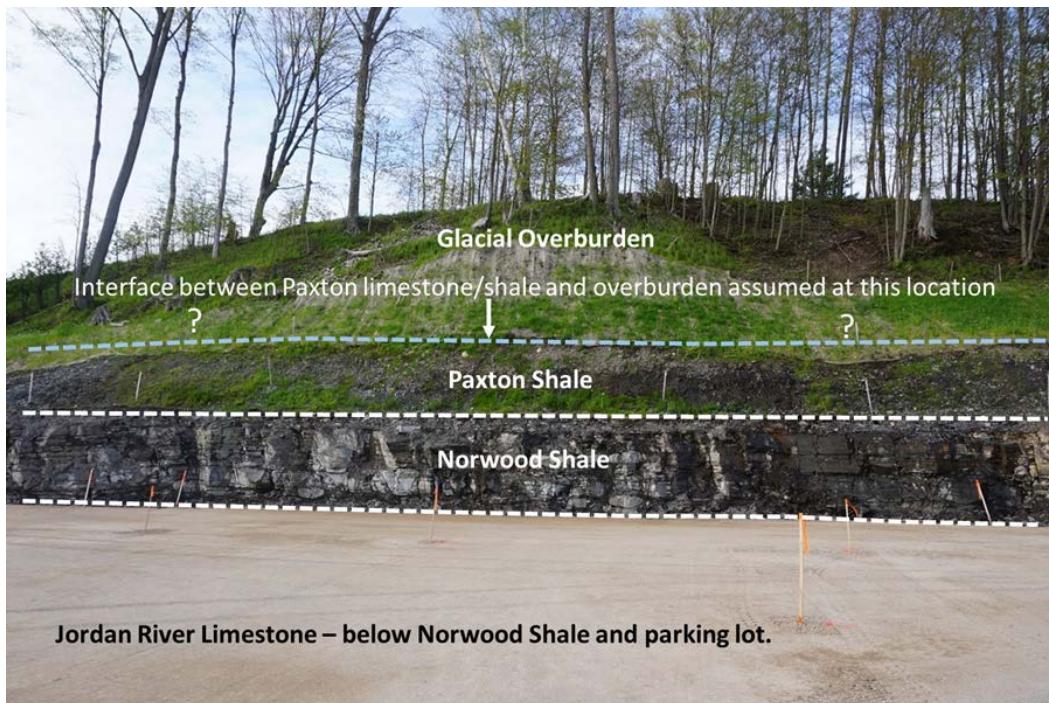
The overall stability (or global stability) of the wall was investigated using a standard limit equilibrium analysis program from Rocscience called Slide version 8.015. To conduct this analysis, the slope was assigned the following four units from top to bottom: (1) glacial overburden, (2) Paxton Sghale-Limestone, (3) Norwood Shale, and (4) the Jorden River Limestone as shown in Figure 13 and Figure 14.

Figure 13 Soil and rock delineation of the Camp Sea Gull Slope.

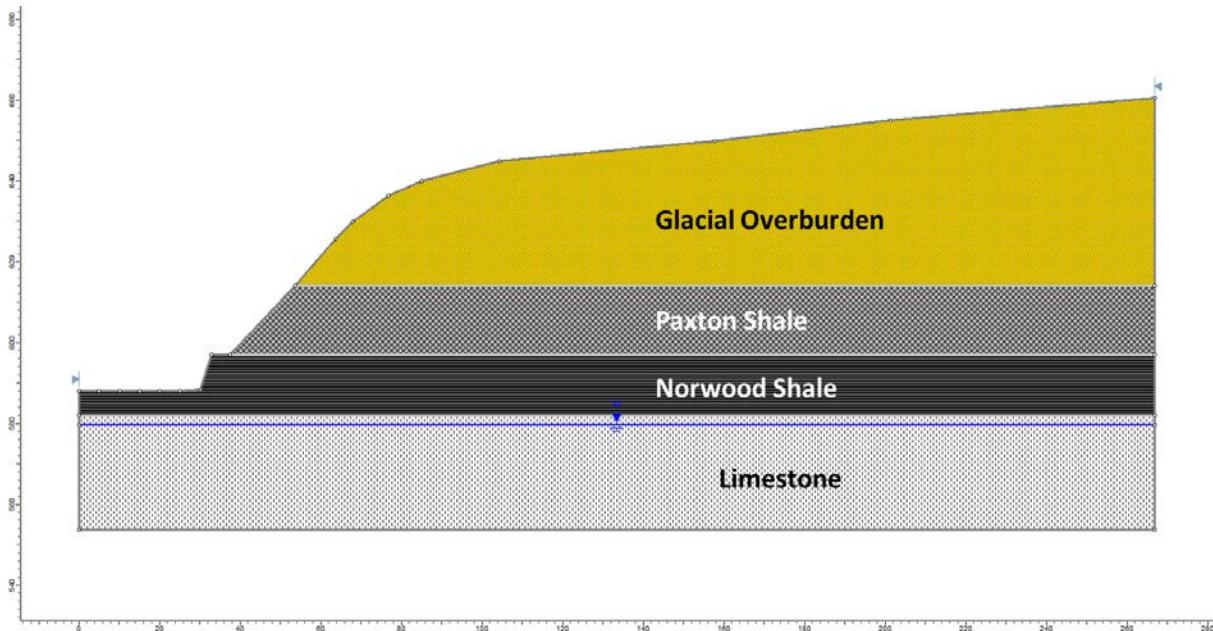
Figure 14 Model used to assess the stability of the Camp Sea Gull slope.

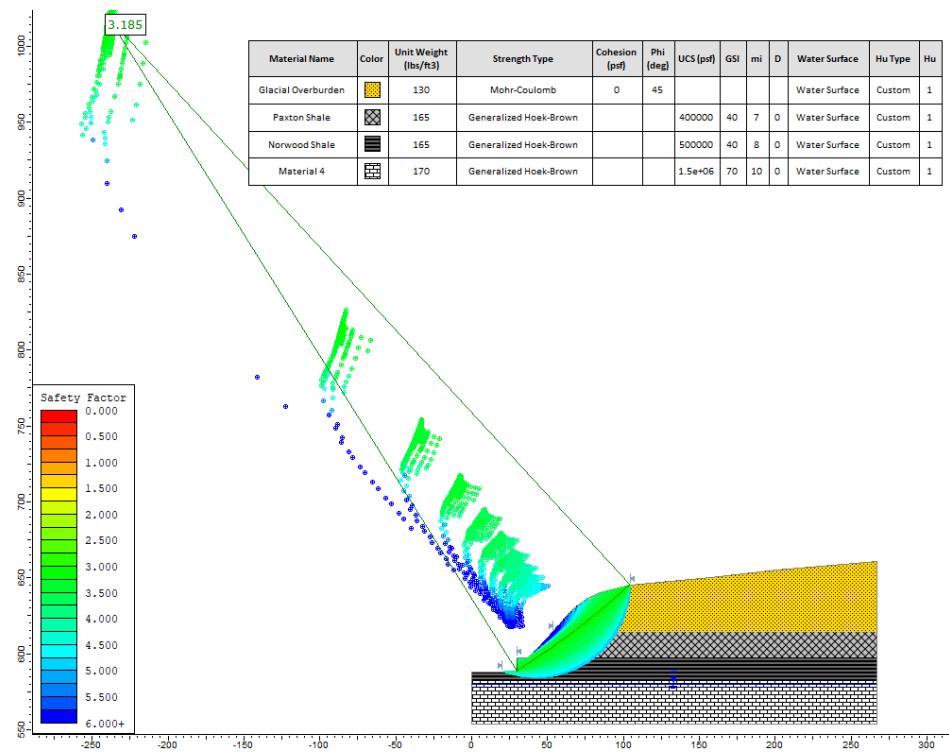
Figure 15 Slope stability analysis for the “likely” strength assumptions.

An assessment of the rock units indicates that there are no planes of weakness that can affect that stability of the wall negatively. Thus, a standard limit equilibrium stability analysis was conducted assuming a circular failure surface. The results of the slope stability analysis are provided in Table 6, while the three analysis are shown in Figure 15, Figure 16, and Figure 17.

Based on this analysis, the shale wall is stable and will not need reinforcement. As seen with Norwood Shale at the Paxton Quarry and along the Lake Michigan shoreline, a near vertical wall will remain stable over time.

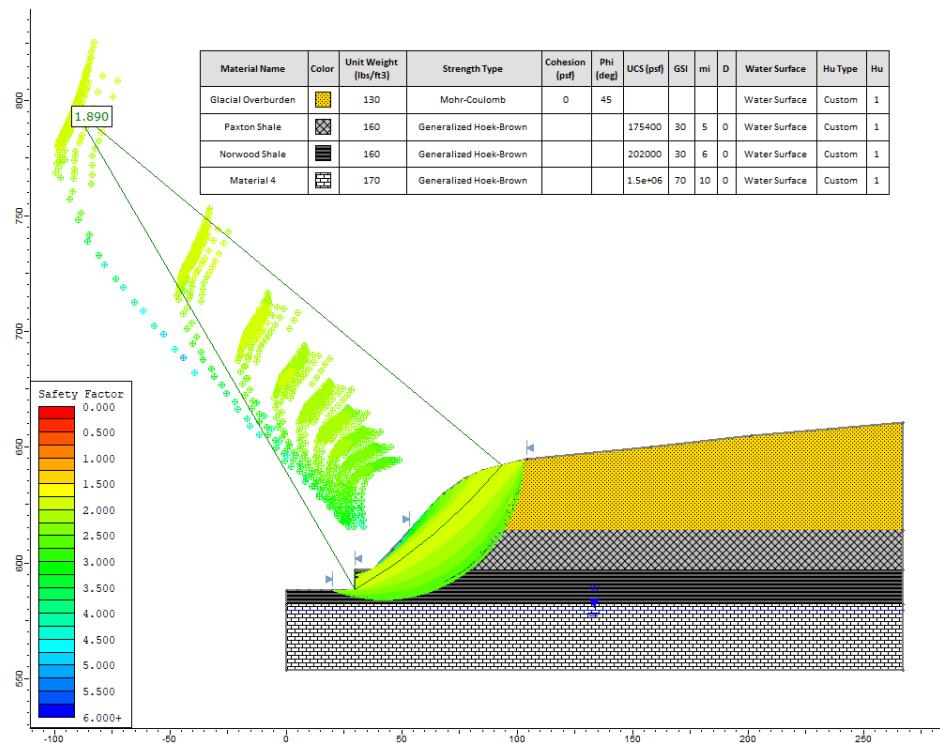
Figure 16 Slope stability analysis for “conservative” strength assumptions.

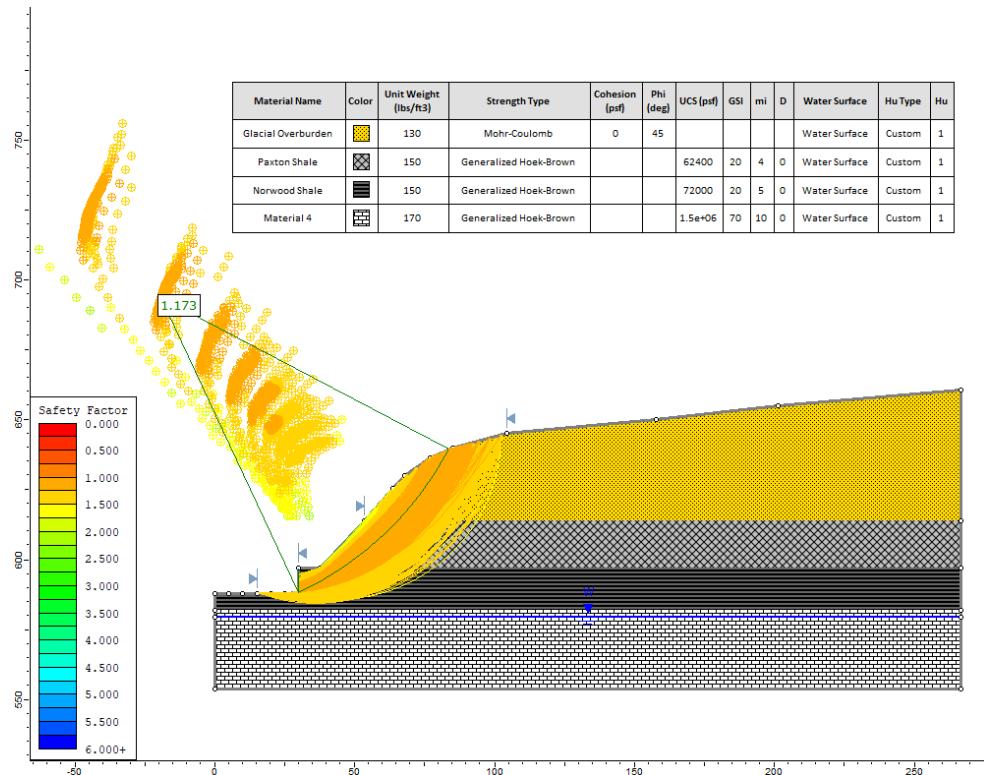
Figure 17 Slope Stability Analysis for "weathered" strength assumptions.

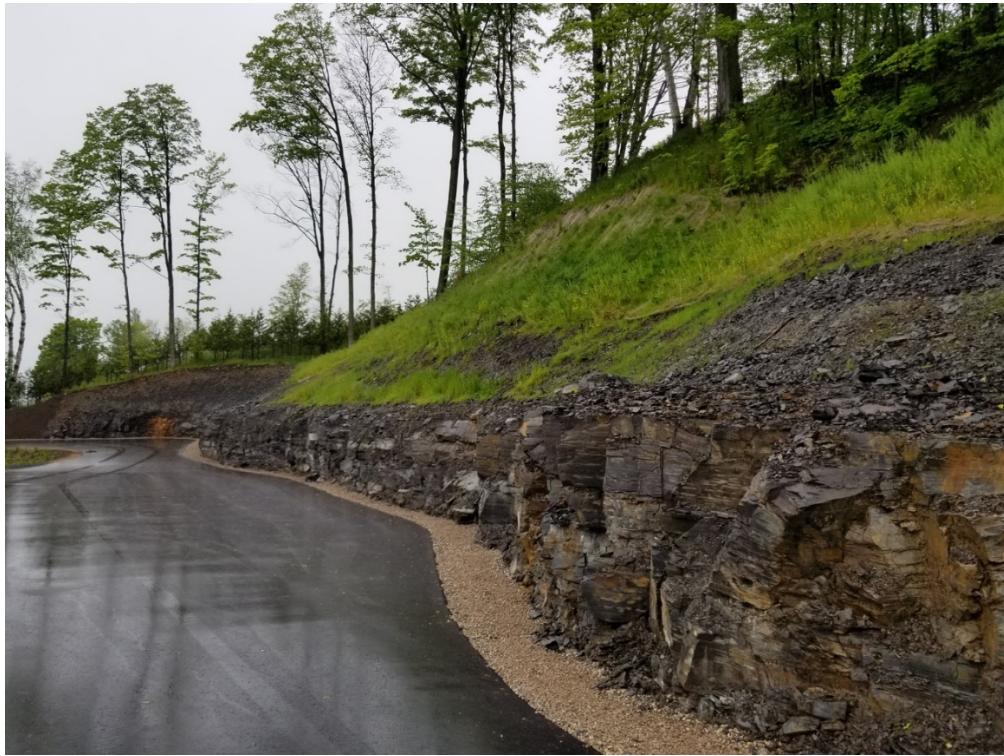
Figure 18 Photo of shale wall taken on June 10, 2019 after scaling and removing the loose debris.

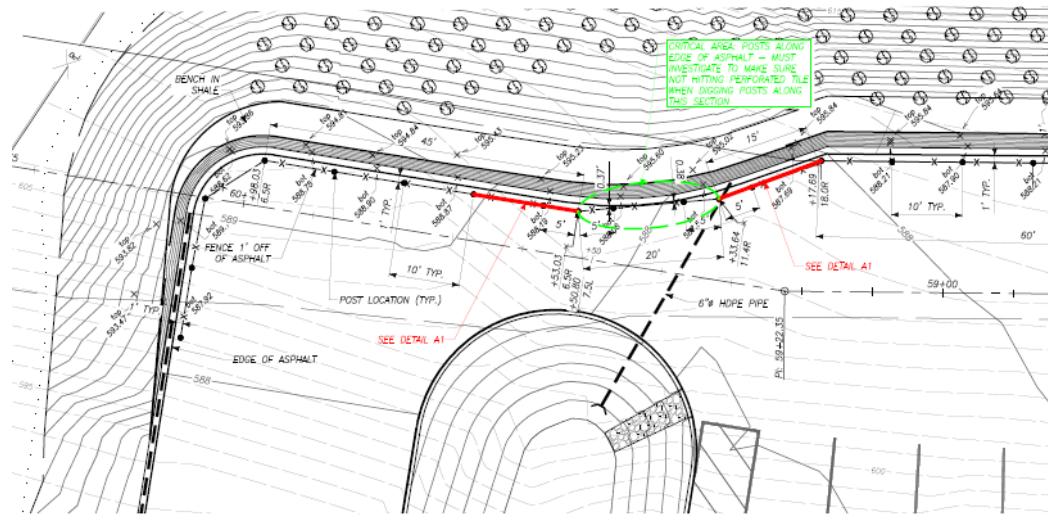
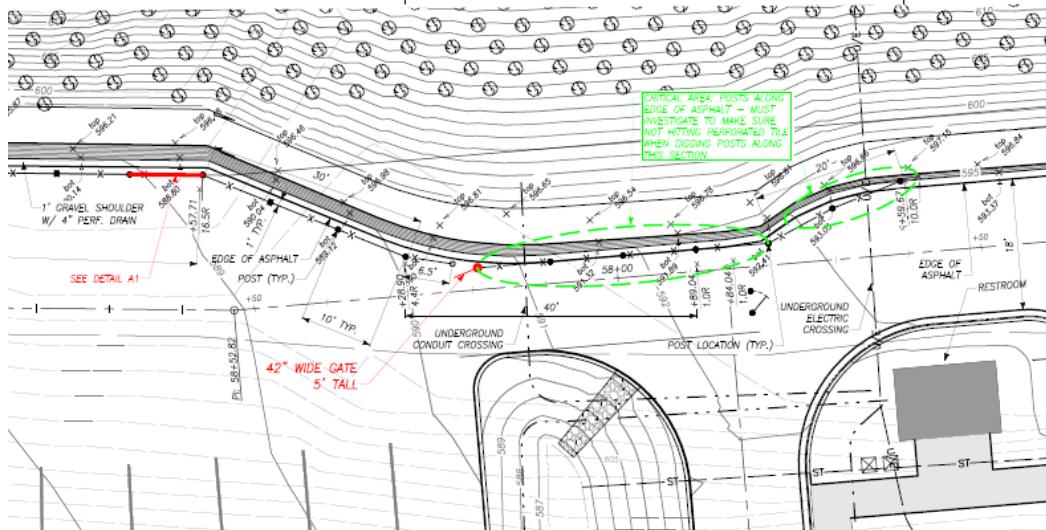
Figure 19 Proposed fence for the shale wall at Sea Gull Park with (a) the northwest section and (b) the northeast section.

Due to the jointing and lamination of the shale, the exposed wall will have some breakage over time, which will result in a small talus slope (broken rock) forming along the wall. To protect the public from falling rock due to breakage and possible toppling failures of loose sections of the wall, I am recommending that a fence be placed in front of the shale wall. A five-foot high fence will be adequate. The distance between the fence and the rock wall can be variable but should be within five feet of the wall. Access locations should be provided to allow inspection of the shale wall. Figure 19 provides a proposed fence location, which should be adequate.
